Subject: Department of Natural Resources Washington Geological Survey,
School Seismic Safety Assessment Project, Contract No. AE 410 -
Seismic Evaluation for **Centralia School District**

1. Edison Elementary School, Main Building

1.1 Building Description

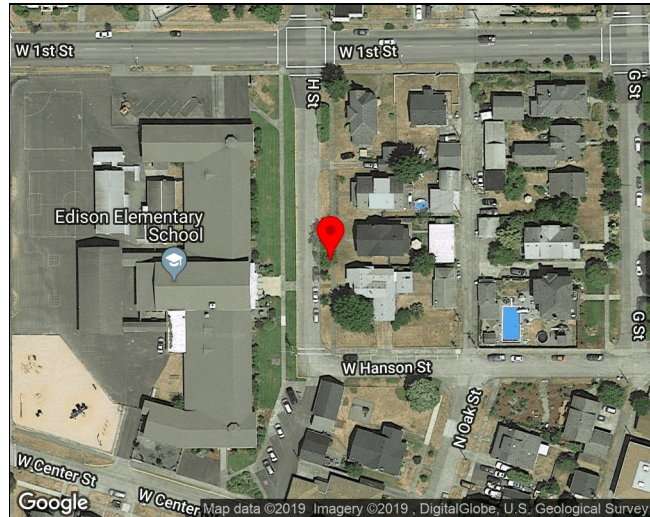
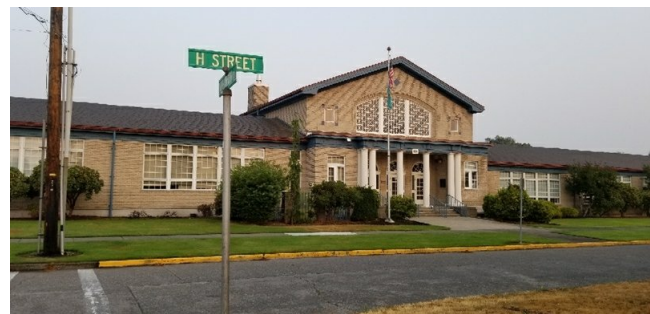
Edison Elementary is a single-story unreinforced masonry school building, measuring approximately 340 feet by 125 feet at its greatest plan extents. The building is approximately 15 feet tall at the eaves, except the middle portion of the building is a high-story with an approximately 25 foot high eave. There is a partial basement under the center, high bay structure. The school was constructed in 1918, with additional classrooms added in 1921-1922. Two more classrooms, a music room added to the gym, a kitchen, and new restrooms were added in 1957. The structure underwent a modernization remodel in 1987-1988. After the Nisqually earthquake in 2001, some emergency repairs were made to remedy extensive damage to the foyer, but it does not appear that the structure was evaluated for seismic resistance at that time.
